# ROBOCUPJUNIOR RESCUE LINE 2024

## ENGINEERING JOURNAL

### Team BitFlip

This Engineering Journal details the development of our robot for the RoboCupJunior Rescue Line competition in 2024. We have developed many robots, so we are reusing many components, including software from previous robots. This Journal only details the work done on this years' robot.

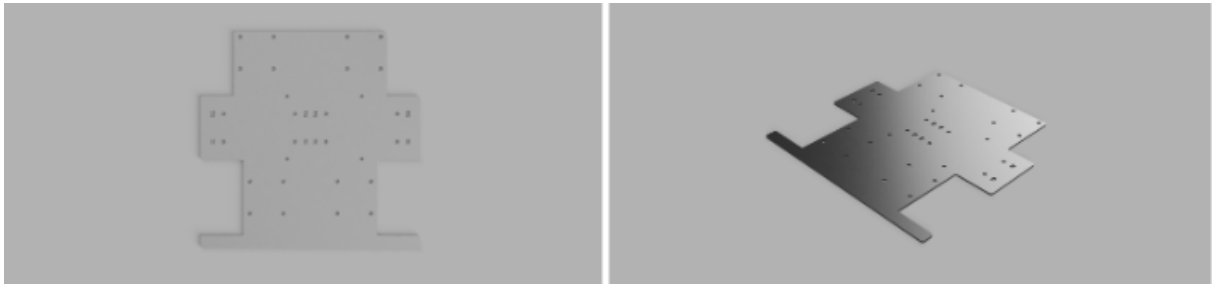
Finished chassis outline based on last year's dimensions, which we are keeping roughly the same:

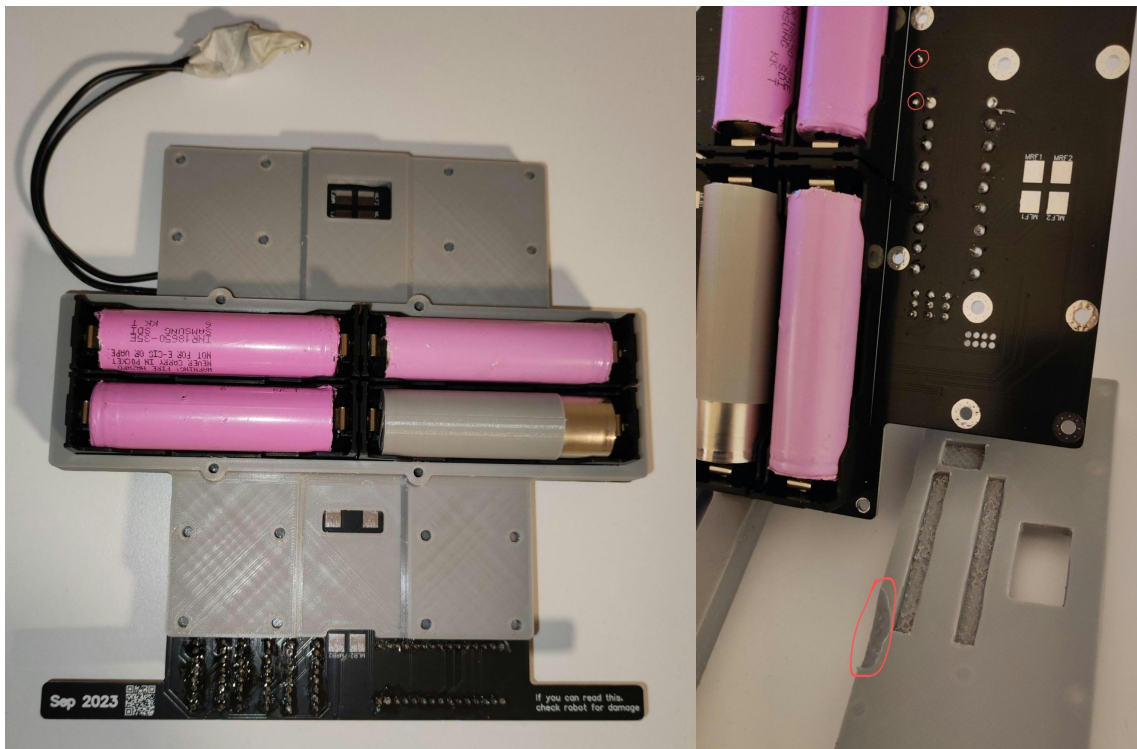
Assembled chassis to PCB, looks good so far (Fig. 1), but we forgot to add two small holes for resistor legs. Fixed using soldering iron (Fig. 2)

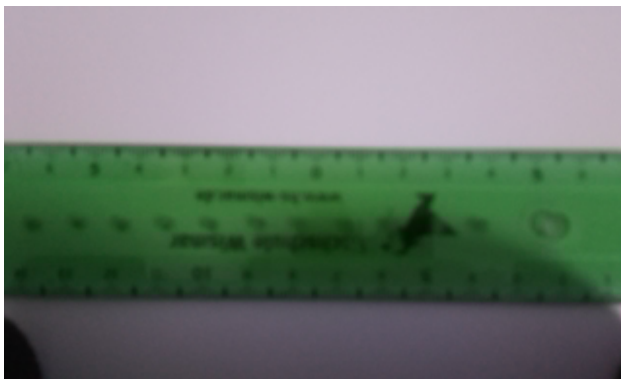
First main program build. Test image from RasPi camera:

First test of line following. Hard to tell how well it works without proper light installed. Line angle algorithm and green detection work.

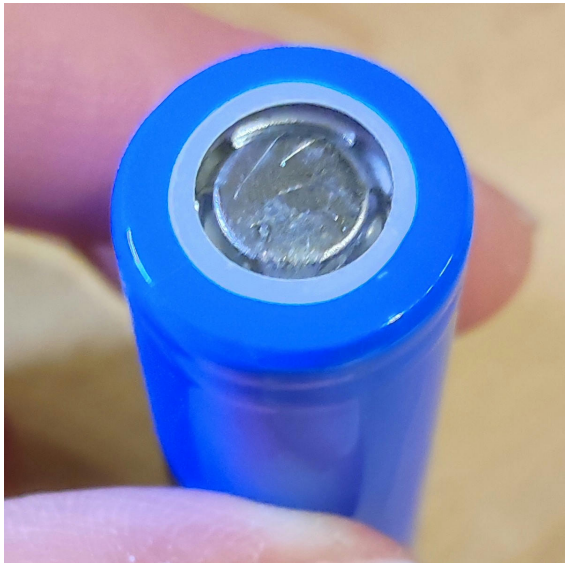
Isolated old 18650 batteries to enhance safety:
